17th St Canal Floodwall, Orleans Parish, Vets to Lake Field Trip 8 Nov 94 Photo Captions

MEMORANDUM FOR FILE

SUBJECT: 17th Street Canal Floodwall, Orleans Parish,

Vets to Lake, Field Trip Report

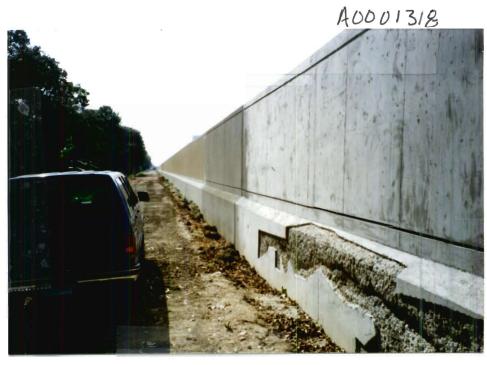
Photo No.	Remarks
1	General view of defective wall and access road looking towards Vets Hwy.
2 - 4	Area where honeycombed concrete was removed by Contractor.
5 - 6	Note layering of concrete on bottom left of defective area. Note feathered edges along bottom center of defective area.
6 - 8	Deep area of honeycombing near steel bar.
9 - 10	Deep area near expansion joint
11	View of adjacent monolith looking towards lake.
12	General view of wall and access road looking towards lake.

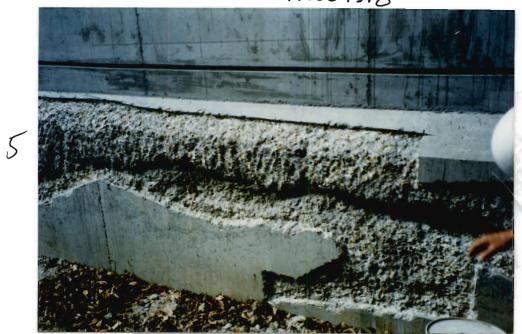
- 6. Observations: See photos with captions.
- 7. <u>Conclusions</u>: The monolith can be repaired by patching to achieve its desired function. Some additional concrete needs to be removed near the bottom center as shown in photo 5. Additionally, a few more edges need to be sawcut rather than left feathered.

- 8. Recommendations: Remove the additional concrete as shown in photo 5 and sawcut the edges that are still feathered. Saturate the surface for about 12 hours prior to patching. Allow the surface to begin the drying process the night before patching. Apply a neat cement mortar as a bonding agent, then dry pack a material as described in the specs. White cement is not necessary since the wall will be coated with cementitious paint. Protect and cure the patched area as specified.
